# Failure Analysis of Large Alloy Steel and White Iron Castings

Robert B. Schrock  
ME Global, Tempe, Arizona, USA

Copyright 2024 American Foundry Society

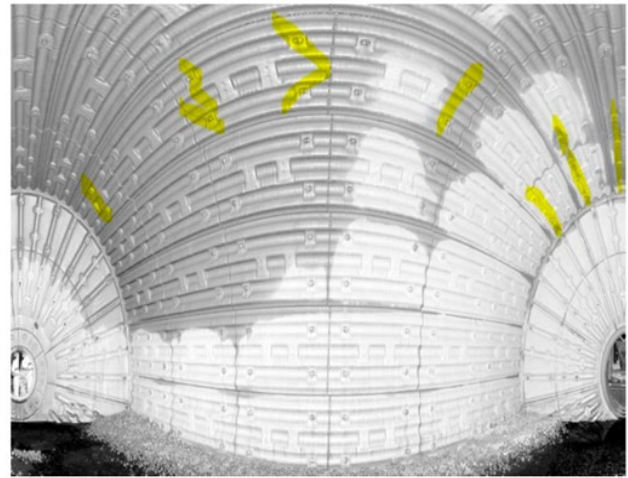
**Figure 4. Wide angle view of a ball mill interior with fractures identified in yellow. (Artwork courtesy of ME Global.)**

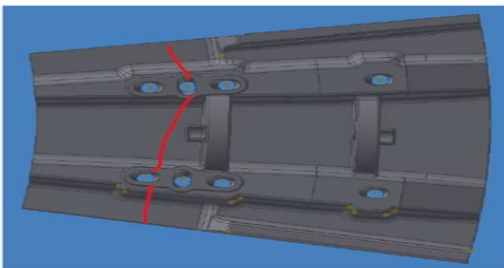
Bolt hole shoulders showed evidence of wear damage indicating possible alignment issues during installation. Excessive bending stresses imposed on the fit side may have been caused by mill shell mating surface conditions, mill shell fit-up and bolting procedures during installation.

Fracture morphology indicated all fractures initiated from the fit surface of each casting. Fractures were brittle in nature, which is typical for white iron, and initiated either near a bolt hole or at locations of high stress as shown in Figures 8 and 9.

**Figure 8. Drawing indicating fracture location.**

Previous investigations at this copper mine have shown head liner castings have historically fractured in a similar fashion. All breakages occurred soon after installation and initiated from the fit side. To avoid the risk of future failures, recommendations were to review all aspects of the installation process including visual examination and laser scanning of mill shell mating surfaces, laser scanning mill liner fit surfaces prior to installation, and reviewing bolting procedures. Note that similar breakages of head liners were previously occurring in another AG mill at the same copper mine, and a re-designed head liner was produced and installed which eliminated breakage. The same redesigned head liner could be installed in this mill.

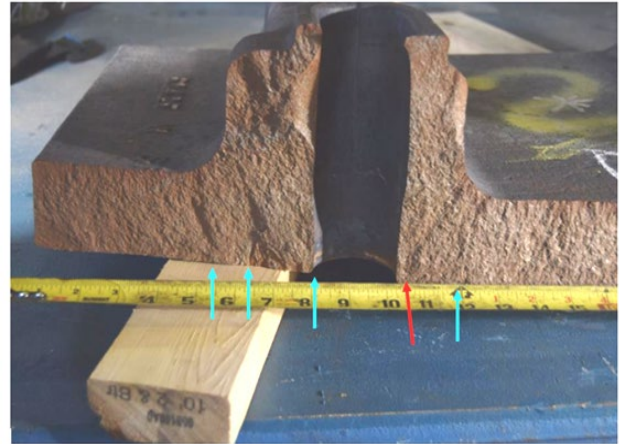
**Figure 9. Locations of high stress on the fit side of a head liner near the bolt hole.**

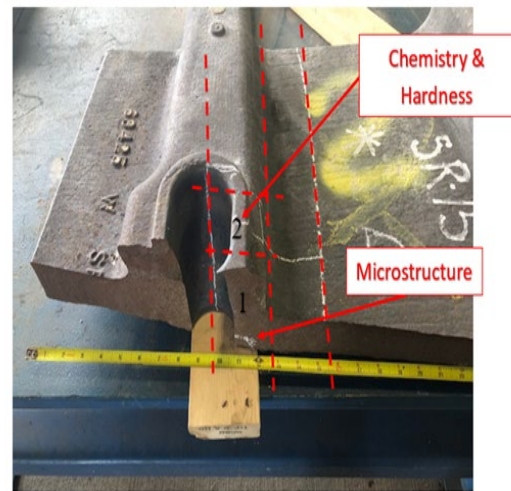
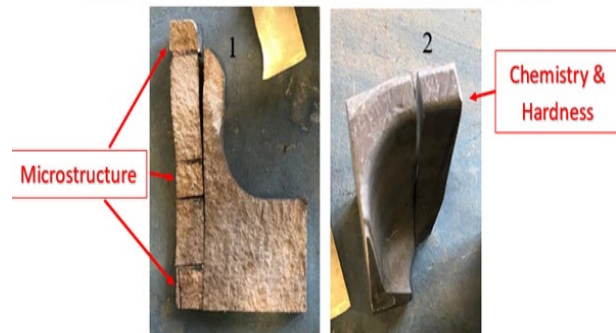
At locations similar to the ones shown in Figure 10, each analyzed sample had chemistry, hardness, and microstructure within specification for heat treated white iron castings. No evidence of entrapped debris, abnormal microporosity, or large inclusions were found near the initiation sites that would have facilitated crack initiation.

**Figure 10. Sectioning and locations for chemistry, hardness and microstructure analysis.**

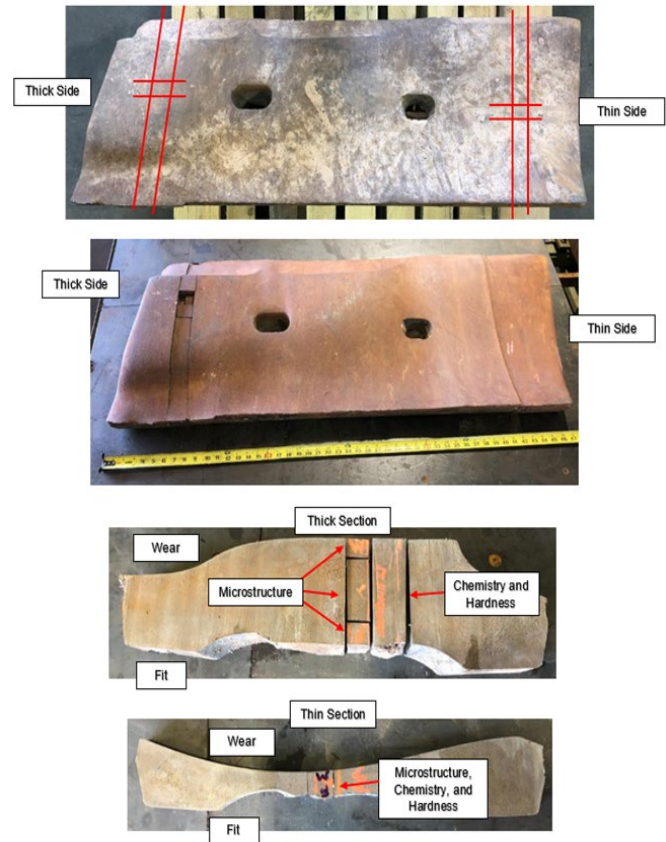
Abnormal wear was likely caused by the milling environment and was not attributed to casting quality.

Middle shell liner production records for the liner serial number submitted for analysis did not reveal non-conformances that would have contributed to accelerated and uneven wear in service. Chemistry, surface hardness and nondestructive testing (NDT) inspection results reviewed by the foundry all showed conformance to alloy specification and inspection requirements. Uneven wear shown in Figure 11 did not occur on feed end or discharge end alloy steel liners that also met quality specifications. No abnormalities were noted by visual inspection.

**Figure 11. Wear profile, sectioning plan and sample locations.**

No obvious cause for the accelerated wear could be determined. Abnormal mill operation by the customer should be avoided. Design modifications to increase lifter height could be considered to extend mid shell liner service life.

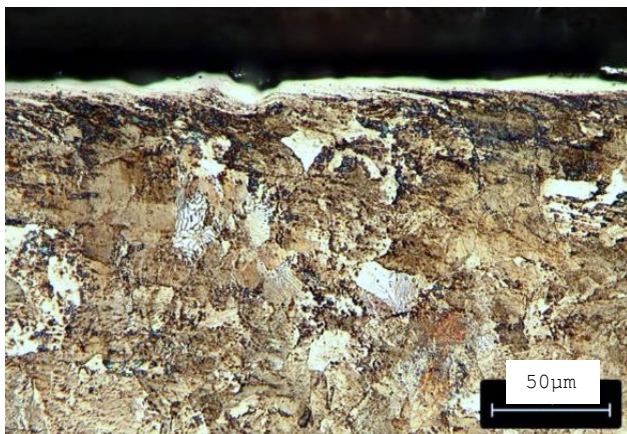
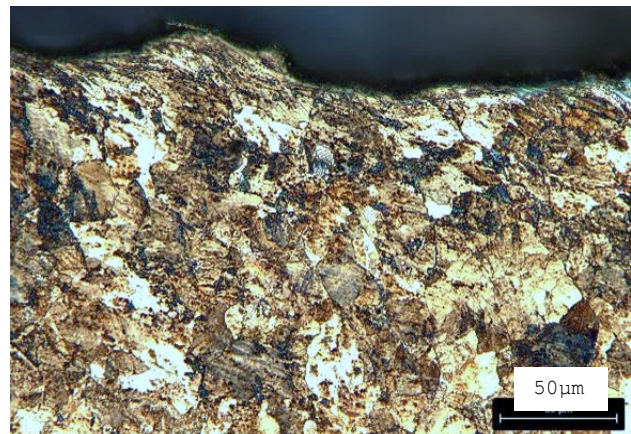
As shown in Figure 12, microstructures of the thickest and thinnest sections of the casting consisted of fine pearlite consistent with properly heat treated alloy steel castings. Through-hardness and chemistry of these sections were typical for this alloy.

**Figure 12. Thick Section wear surface (Left) with small white surface layer of untempered martensite formed by abrasive wear in service along with deformed pearlite, and Thin Section wear surface (Right) showing a smaller layer of deformed pearlite. 2% Nital Etch.**

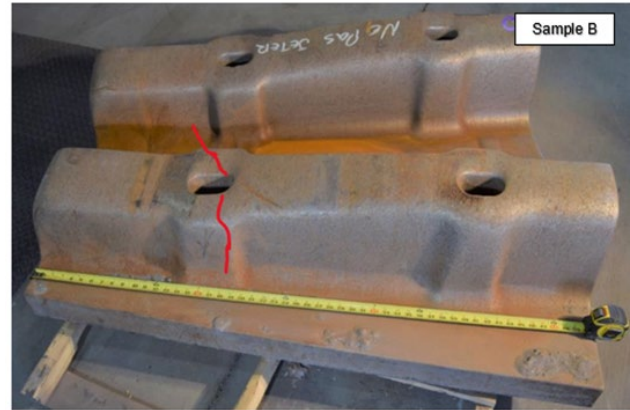
Both head liners selected for analysis had similar fracture features with several crack initiation sites around bolt holes on the fit surface. Some cracks did not run completely through the casting and had to be opened for inspection as shown in Figures 13 and 14. No obvious abnormalities were noted by visual inspection. Fracture initiation sites and fracture directions were random through plate and lift areas. Figure 14 shows fracture fronts either changed directions during propagation or multiple fronts converged, resulting in parts having multiple fracture faces on different planes.

**Figure 13. Image of white iron casting where fracture occurred. Casting had to be broken open to expose the fracture face.**

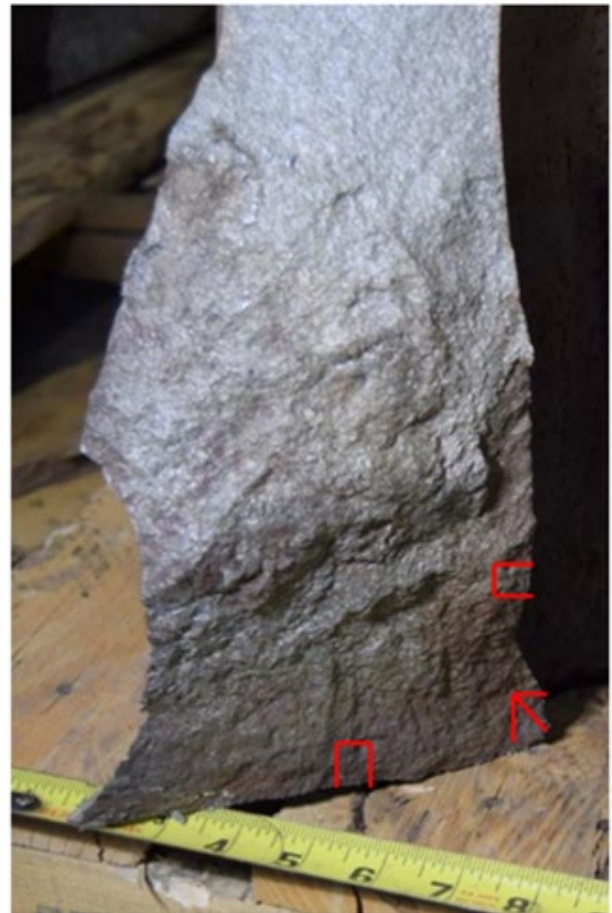
**Figure 14. Sample locations used for microstructure examination. In-service fracture is slightly discolored compared to laboratory fracture to expose the crack.**

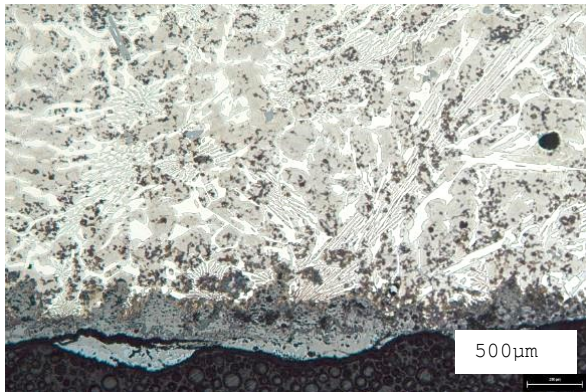
As shown in Figures 16 and 17, microstructure consisted of tempered martensite and eutectic carbides typical of heat treated white cast iron. However, high amounts of non-martensitic phases (pearlite + bainite) were noted throughout both castings, which may have weakened the microstructure. Figure 18 shows entrapped sand particles identified by energy dispersive X-ray spectroscopy (EDS) microanalysis which also may have weakened the microstructure near bolt hole fracture initiation sites.

**Figure 16. Optical micrograph of white iron containing dark-colored non-martensitic phases. 2% Nital etch.**

Sources of entrapped sand should be investigated and eliminated. Improvements in heat treatment should be investigated to minimize the presence of non-martensitic phases.

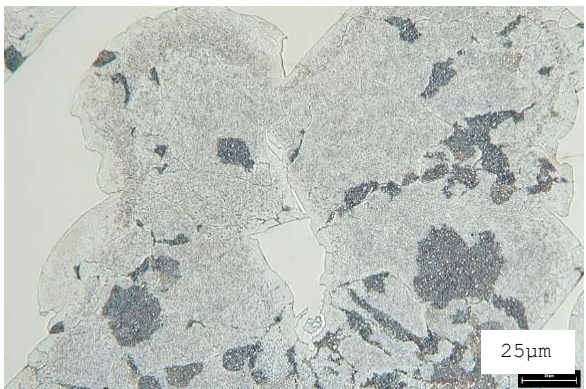
**Figure 17. Optical micrograph of white iron containing non-martensitic phases. 2% Nital etch.**

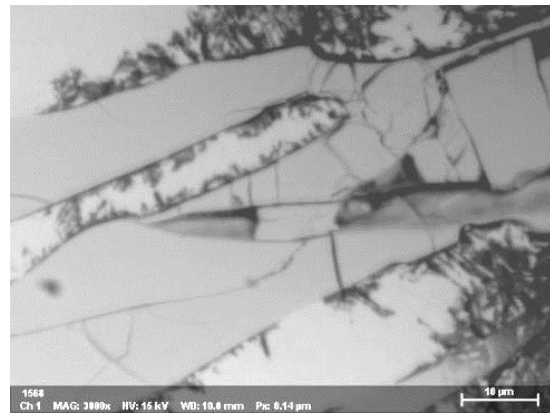
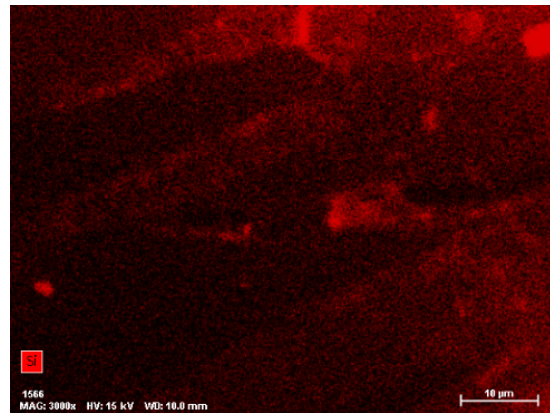
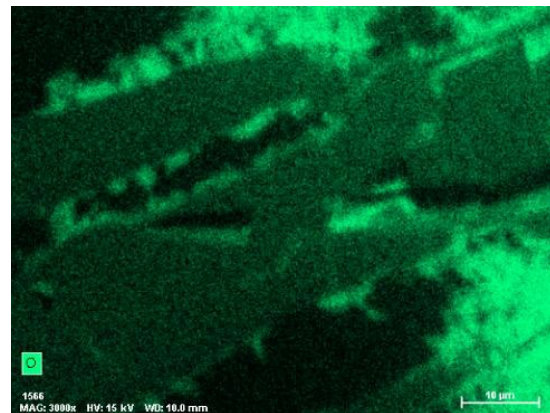
A combination of entrapped sand particles and non-martensitic phases at locations of high stress likely facilitated crack initiation. Cracking extended through weaker areas of the casting until reaching either a surface or a non-compromised region within the casting.

**Figure 18. Backscatter electron image of white iron containing entrapped sand & X-ray EDS maps of silicon and oxygen.**

Perform additional sampling of feed end inner head liners during the next production run, including destructive testing, as it is unlikely that standard NDT inspection methods will detect entrapped sand particles due to their relatively small size and random distribution.

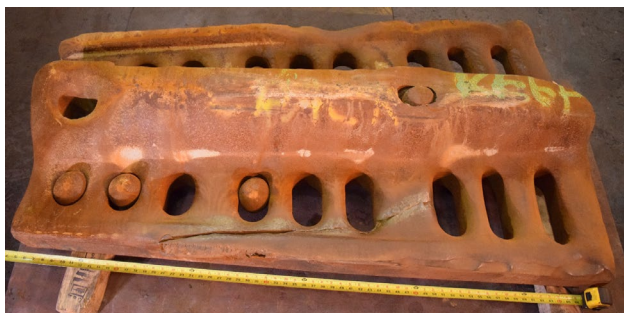
A SAG mill at an iron ore mine had a cracked alloy steel discharge grate that was removed and replaced during a scheduled relining operation. The grate cracked through its webbing along the leading edge at an unknown time during its service life.

**Figure 19. As received casting for failure analysis.**

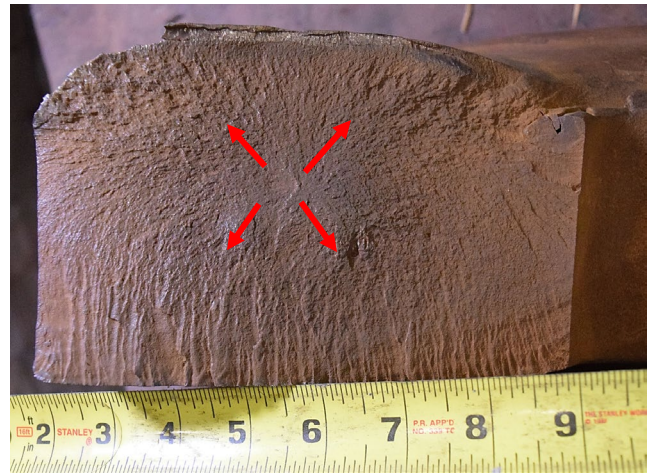
Cracking shown in Figure 20 was attributed to overload imposed on the discharge grate rib which had a higher hardness than specified for heat treated alloy steel grates. Higher hardness was attributed to bainite seen within the pearlite microstructure.

**Figure 20. Fractured alloy steel grate rib showing fracture features. Arrows indicate overload fracture initiation site.**

Review heat treatment procedures and practices to ensure ribs and all other locations on discharge grates have hardness and microstructure within specification. Selecting alternative locations for monitoring still air-cooling temperature on grate castings, and packing rib slots with Kaowool™ ceramic insulation, could help achieve the desired results.

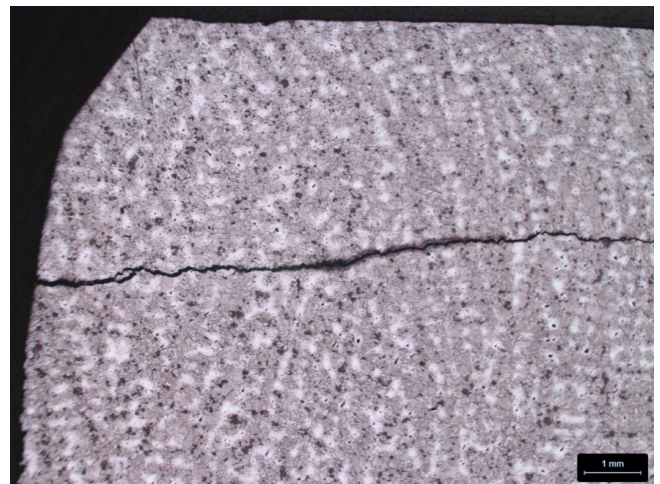
Mixed bainite/pearlite shown in Figures 21 and 22 is undesirable for discharge grates since this microstructure is expected to have lower fracture toughness compared to fine pearlite. Lower fracture toughness can facilitate crack initiation and overload fracture from impact loading imposed on the grate rib in service. Heat treated alloy steel grates are specified to be fully pearlitic with lower hardness and greater impact resistance.

The presence of bainite indicated the grate ribs rapidly cooled during heat treatment to a lower than desired temperature after austenitization. Bulk chemistry was within specification for alloy steel castings.

**Figure 21. Undesired microstructure of pearlite + bainite in a cracked alloy steel grate rib. 2% Nital Etch.**

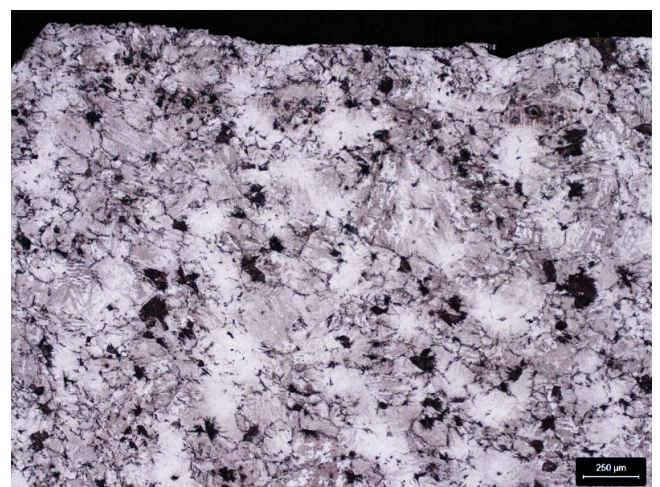
**Figure 22. Undesired microstructure of pearlite (dark) + bainite (grey) at the wear surface of a cracked alloy steel grate rib. 2% Nital Etch.**
