SPONSORED RESEARCH

Quantifying Casting Quality Through Filling Conditions

RESEARCHER: D. Hoefert, Eck Industries Inc.

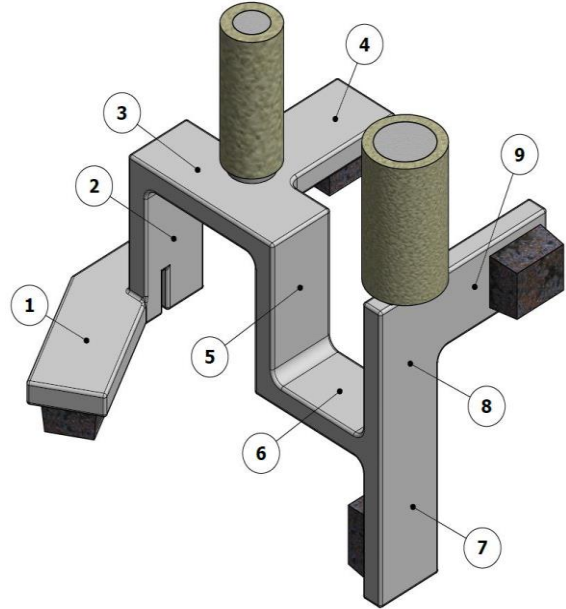
The study is uniquely designed to measure the qualitative effects based on filling conditions. This was accomplished by comparing the quality of leg sections within a test casting. Samples were poured for four different aluminum alloys.
